Walk Audits With MVRPC

HEAL Walk Audit Summary

Yellow Springs Walk Audit Summary

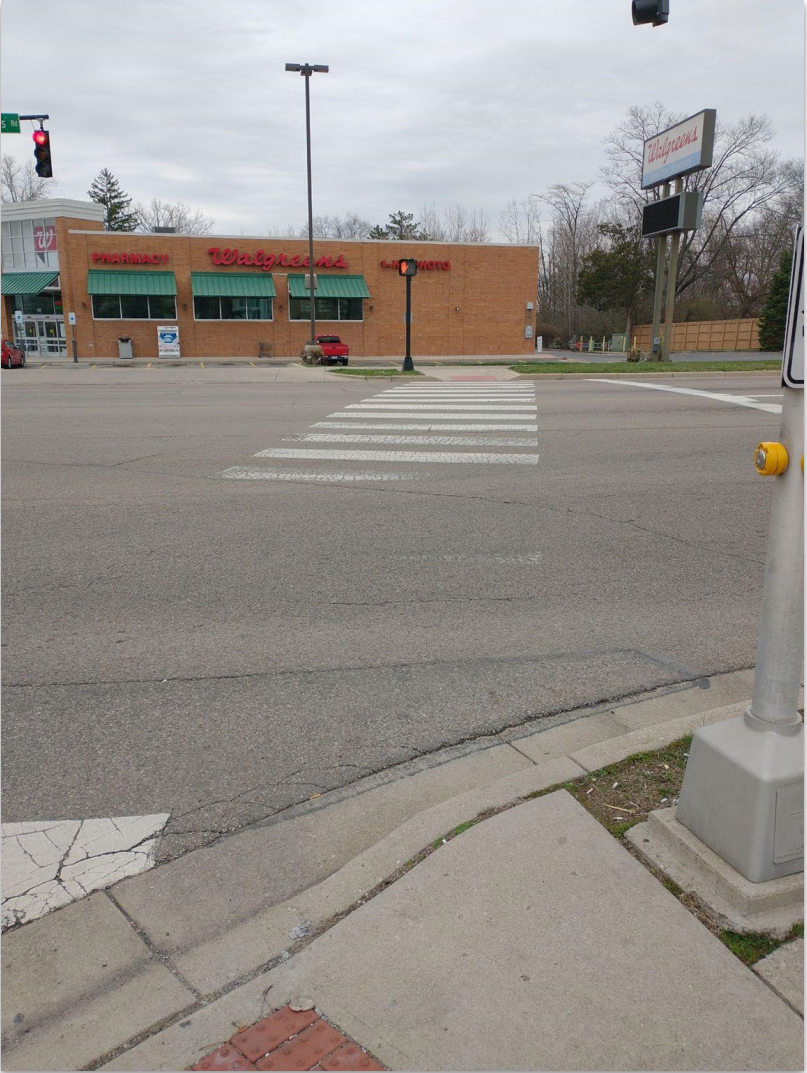
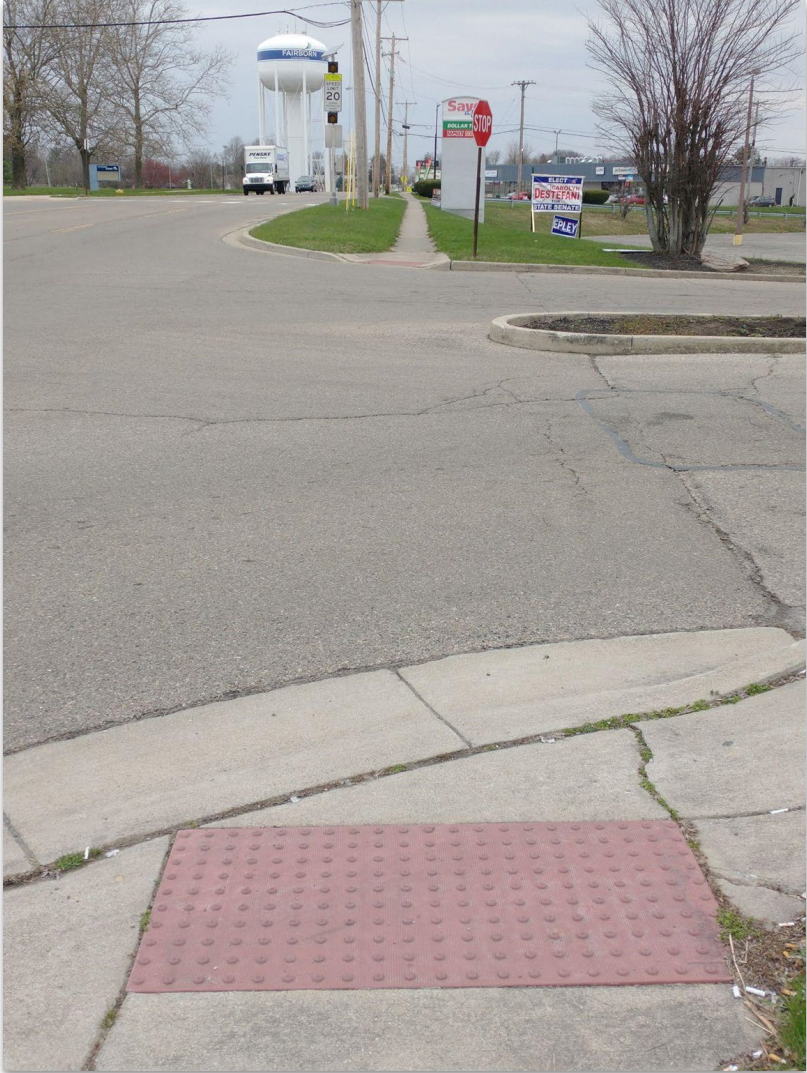
Photos: Five Points area

- Crosswalk paint
- Crossing times feel short
- Some narrow sidewalks (older)
- Auto-centric site design
- Uncontrolled crossings may need updates
- Lack of pedestrian lighting/benches

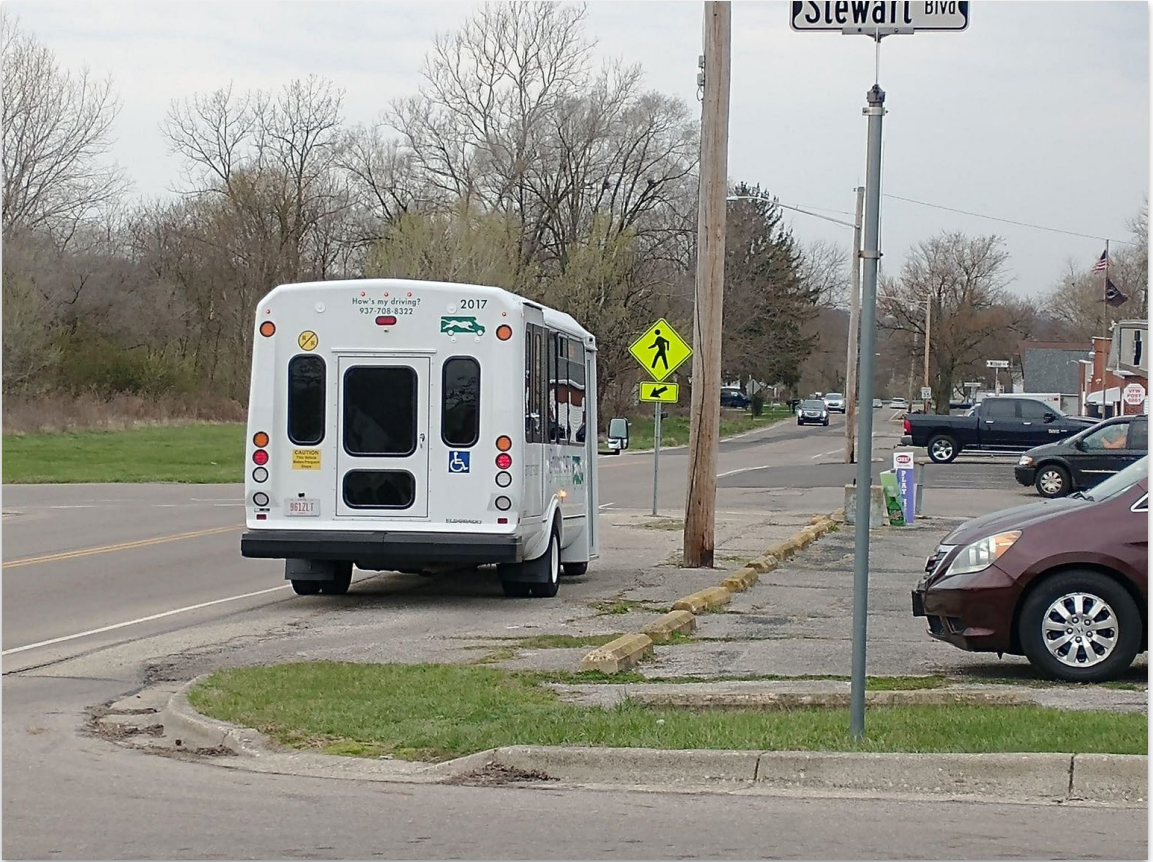
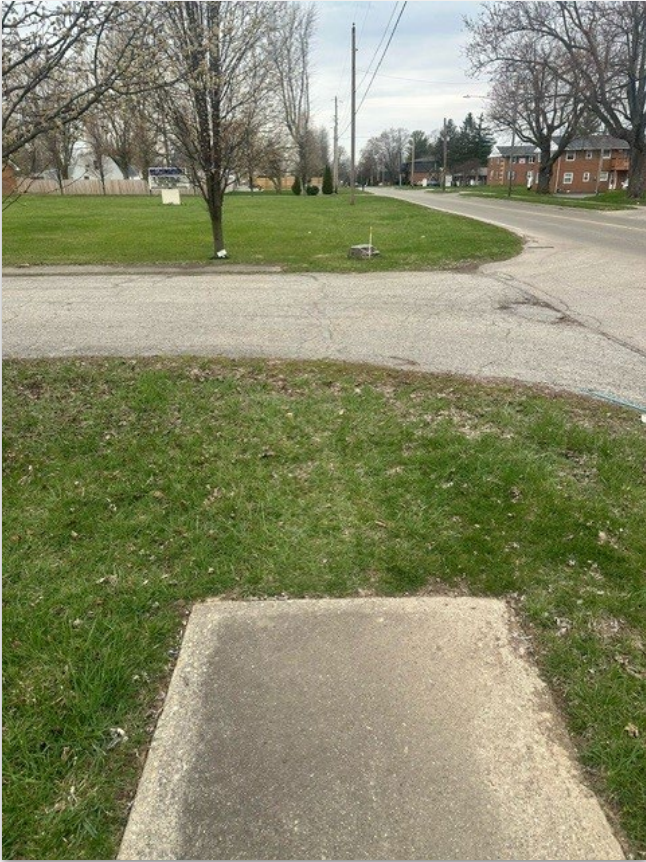
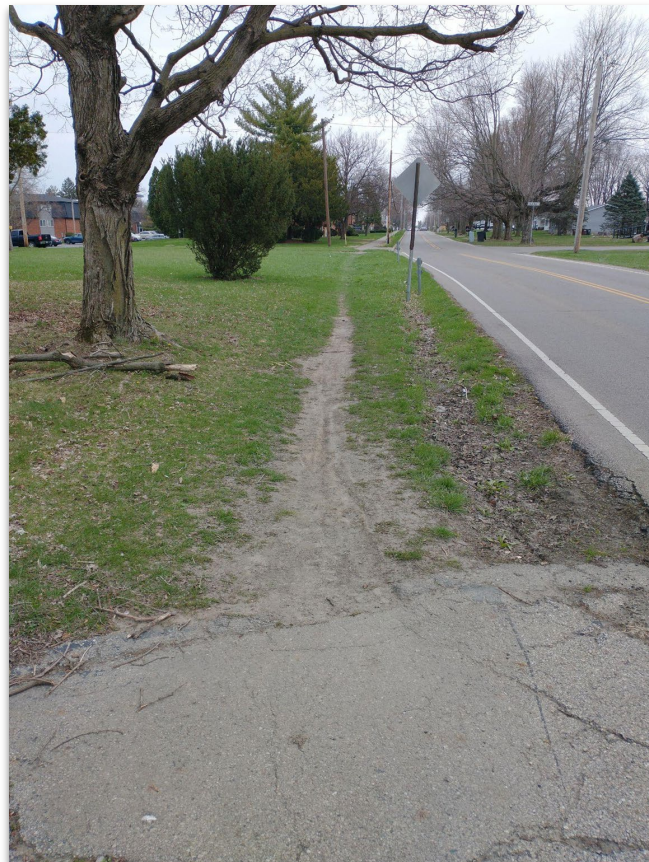
Photos: Funderburg Road

- **Sidewalk gaps**
- Some narrow sidewalks (older)
- Uncontrolled crossings may need updates
- Litter
- Lack of pedestrian scale lighting

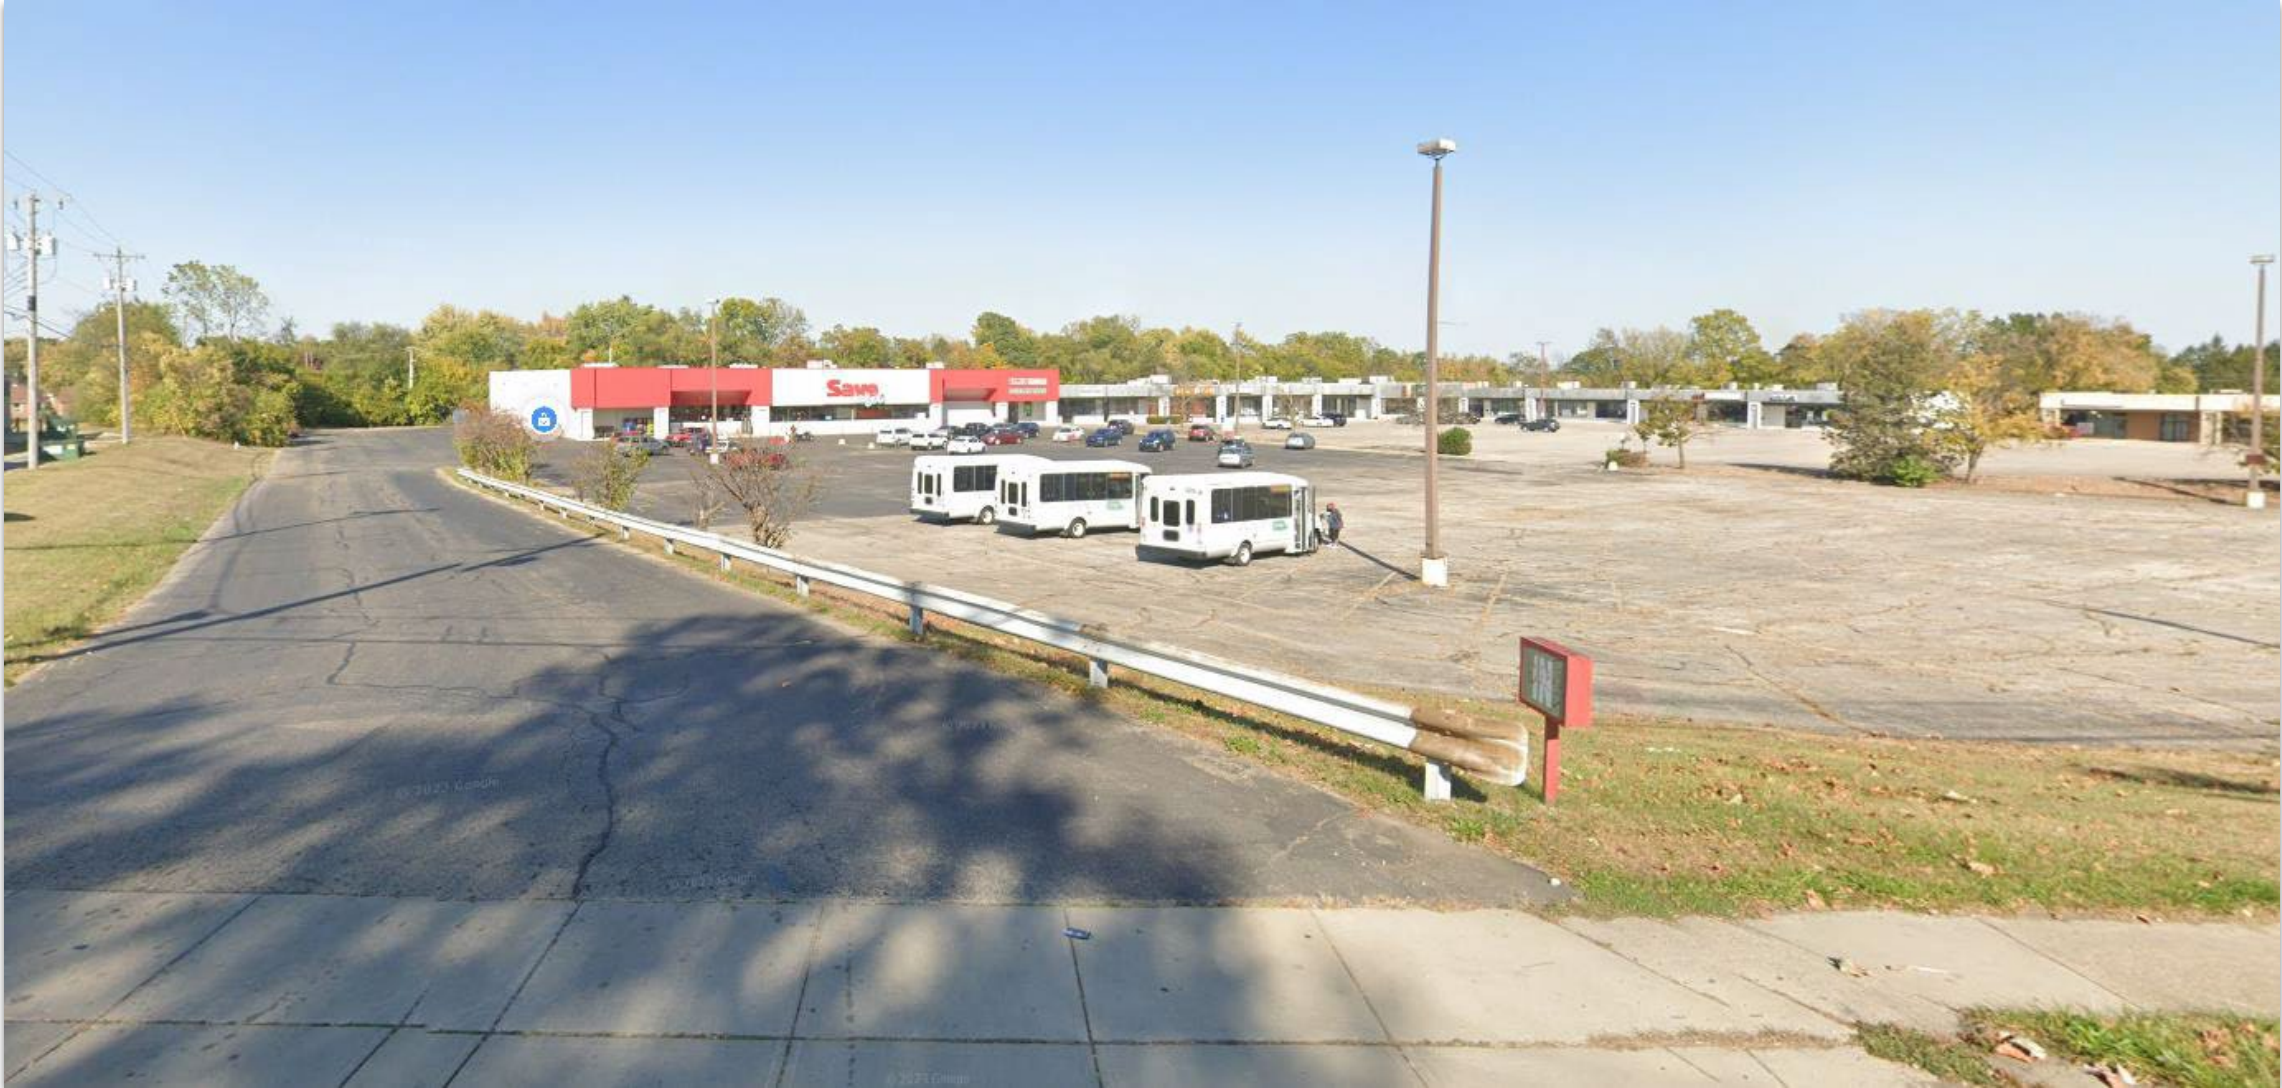
Photos: Park Hills Plaza (Google Streetview, 2023)

- Lack of passenger waiting facilities
 - Shelter, benches, restroom access, drinking water, transit information, lighting
- No pedestrian path for accessing stores or D-YS Road
- Litter

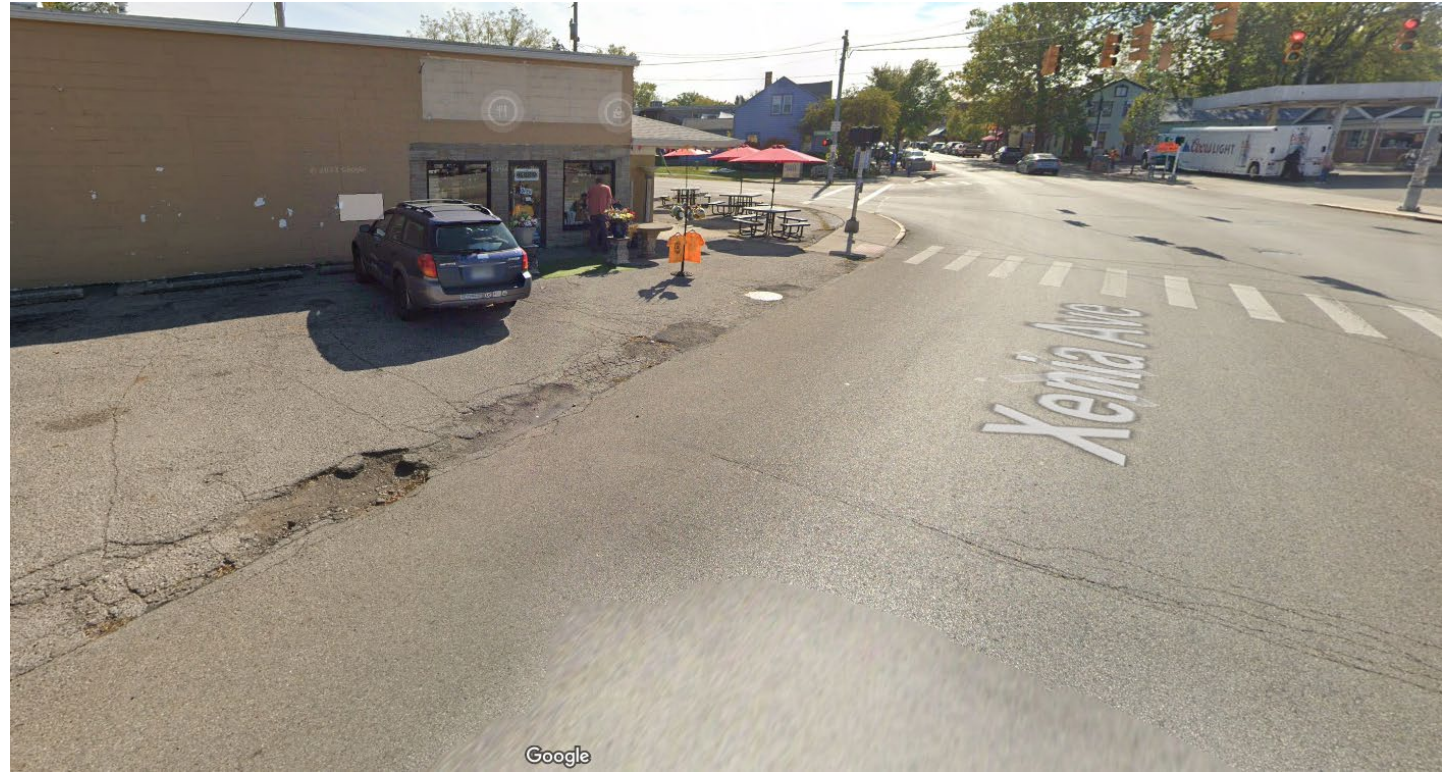
Route 1 (Xenia Avenue, Corry Street, Dayton Street)

- Concern over wet leaves (Particularly in front of bank)
- Concern over lighting in at least one location
- Concerns raised over crosswalks throughout the route

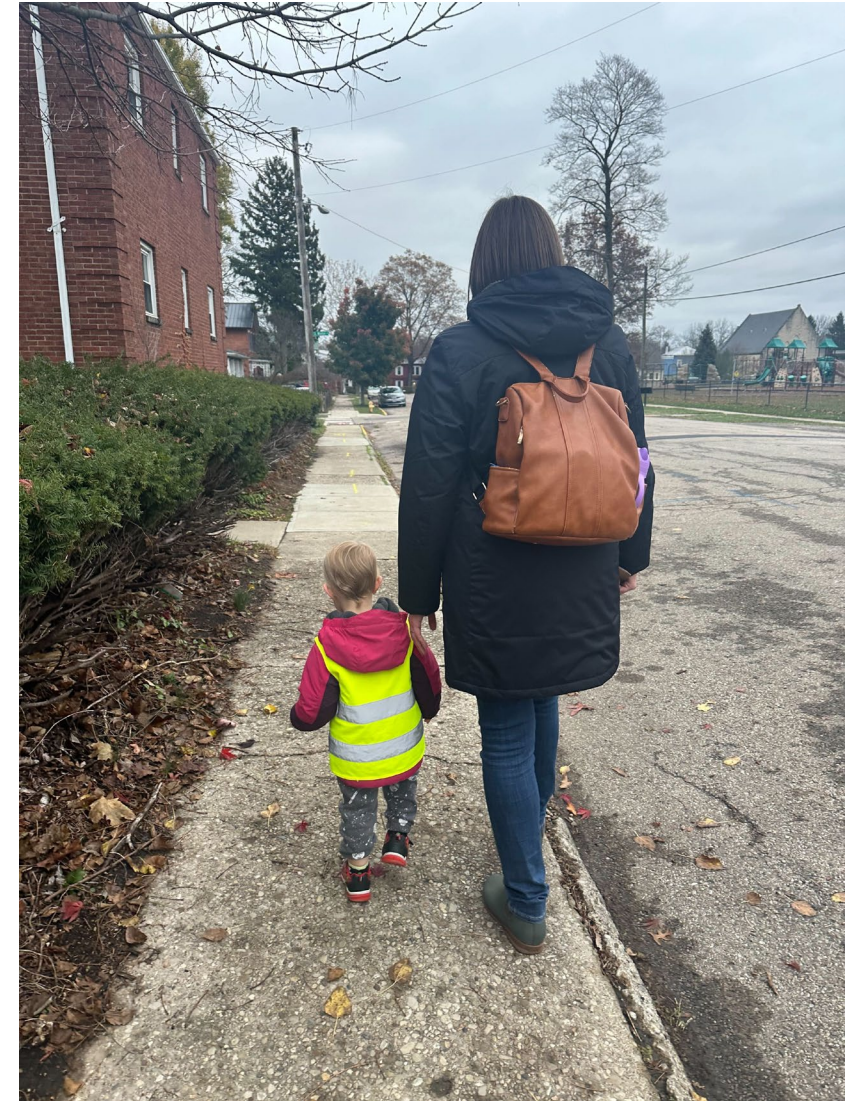
Route 2 (Elm Street, Limestone Street, Walnut Street)

- There were visible obstructions at crossings (Elm and Stafford)
- Lots of cracks in sidewalk all along route
- Lots of leaves and obstructions on sidewalks all along route

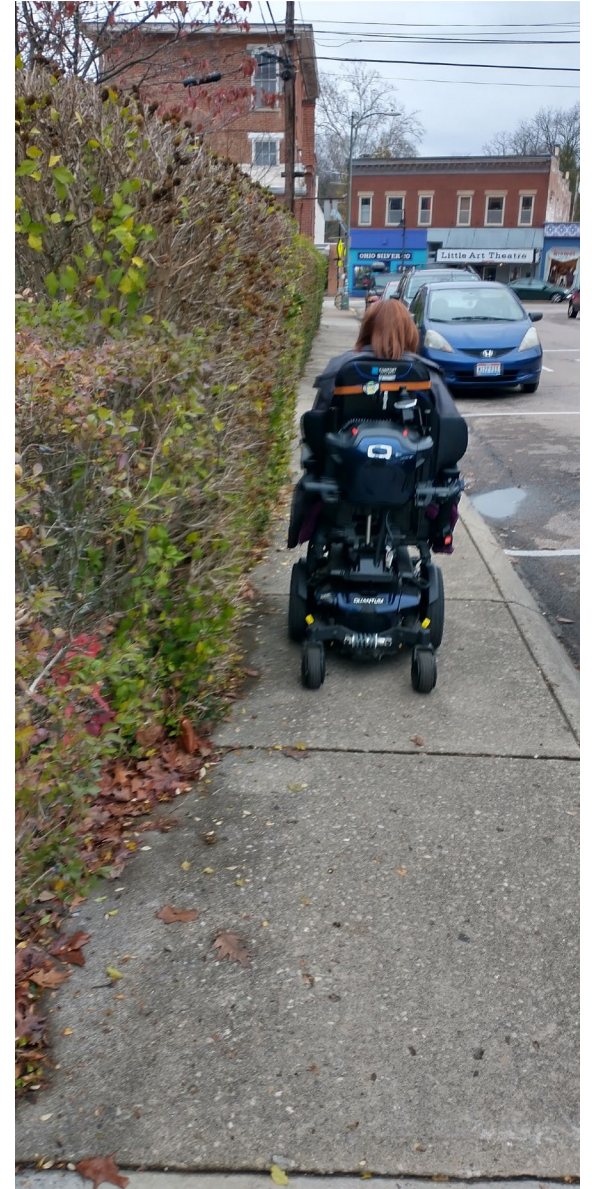
Route 3 (Dayton Street, South High Street, Xenia Avenue)

- Some foliage needs cutting (Causes obstructions)
- Intersection at S Stafford, Elm, Dayton St is difficult for pedestrians because the crosswalks are unclear
- Some streets have sidewalk only located on one side which is ok but not ideal
- Sidewalks have cracks, uneven cement, dirt and mud accumulation all along route
- There should be a blinking crosswalk located at the school
- Pedestrians need to be cautious at crosswalk across Dayton street, however Dayton and Corry are ok with pedestrians
- There are sidewalks that don't go to end of the block in multiple locations
- There are also lots of lifted segments throughout
- There is no access from new multiuse path at Elm Street to get to elementary school

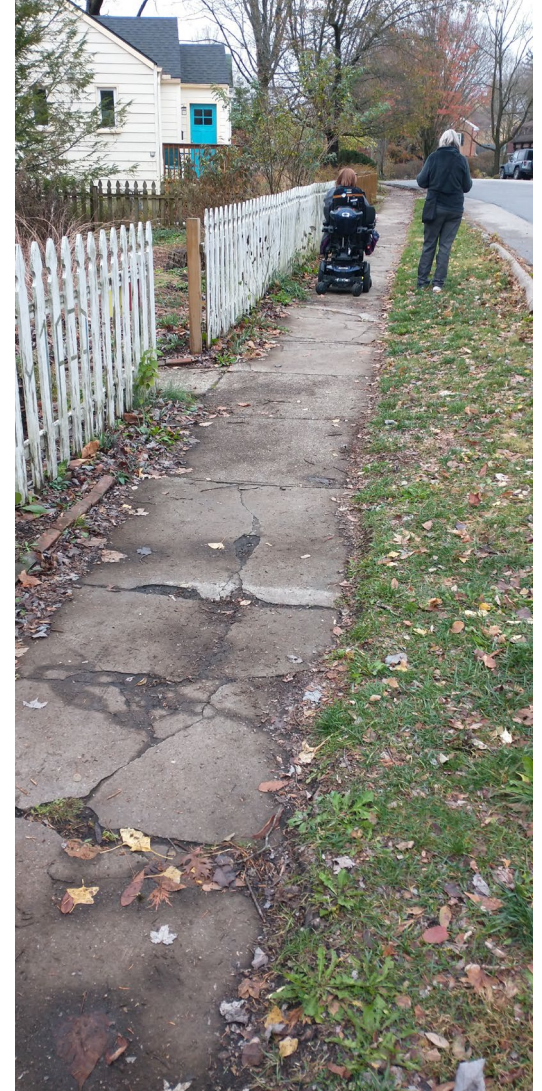
Route 4 (Railroad Street, Cliff Street, Limestone Street, Corry Street)

- There is not a lot of lighting on Cliffs Street
- Walnut sidewalk is too narrow for motor chair
- South Walnut Street has lots of cracks
- There is a sidewalk gap on the south side of limestone (ends abruptly)
- No ADA ramps at Limestone and President
