Walk Audits With MVRPC

HEAL Walk Audit Summary

Yellow Springs Walk Audit Summary

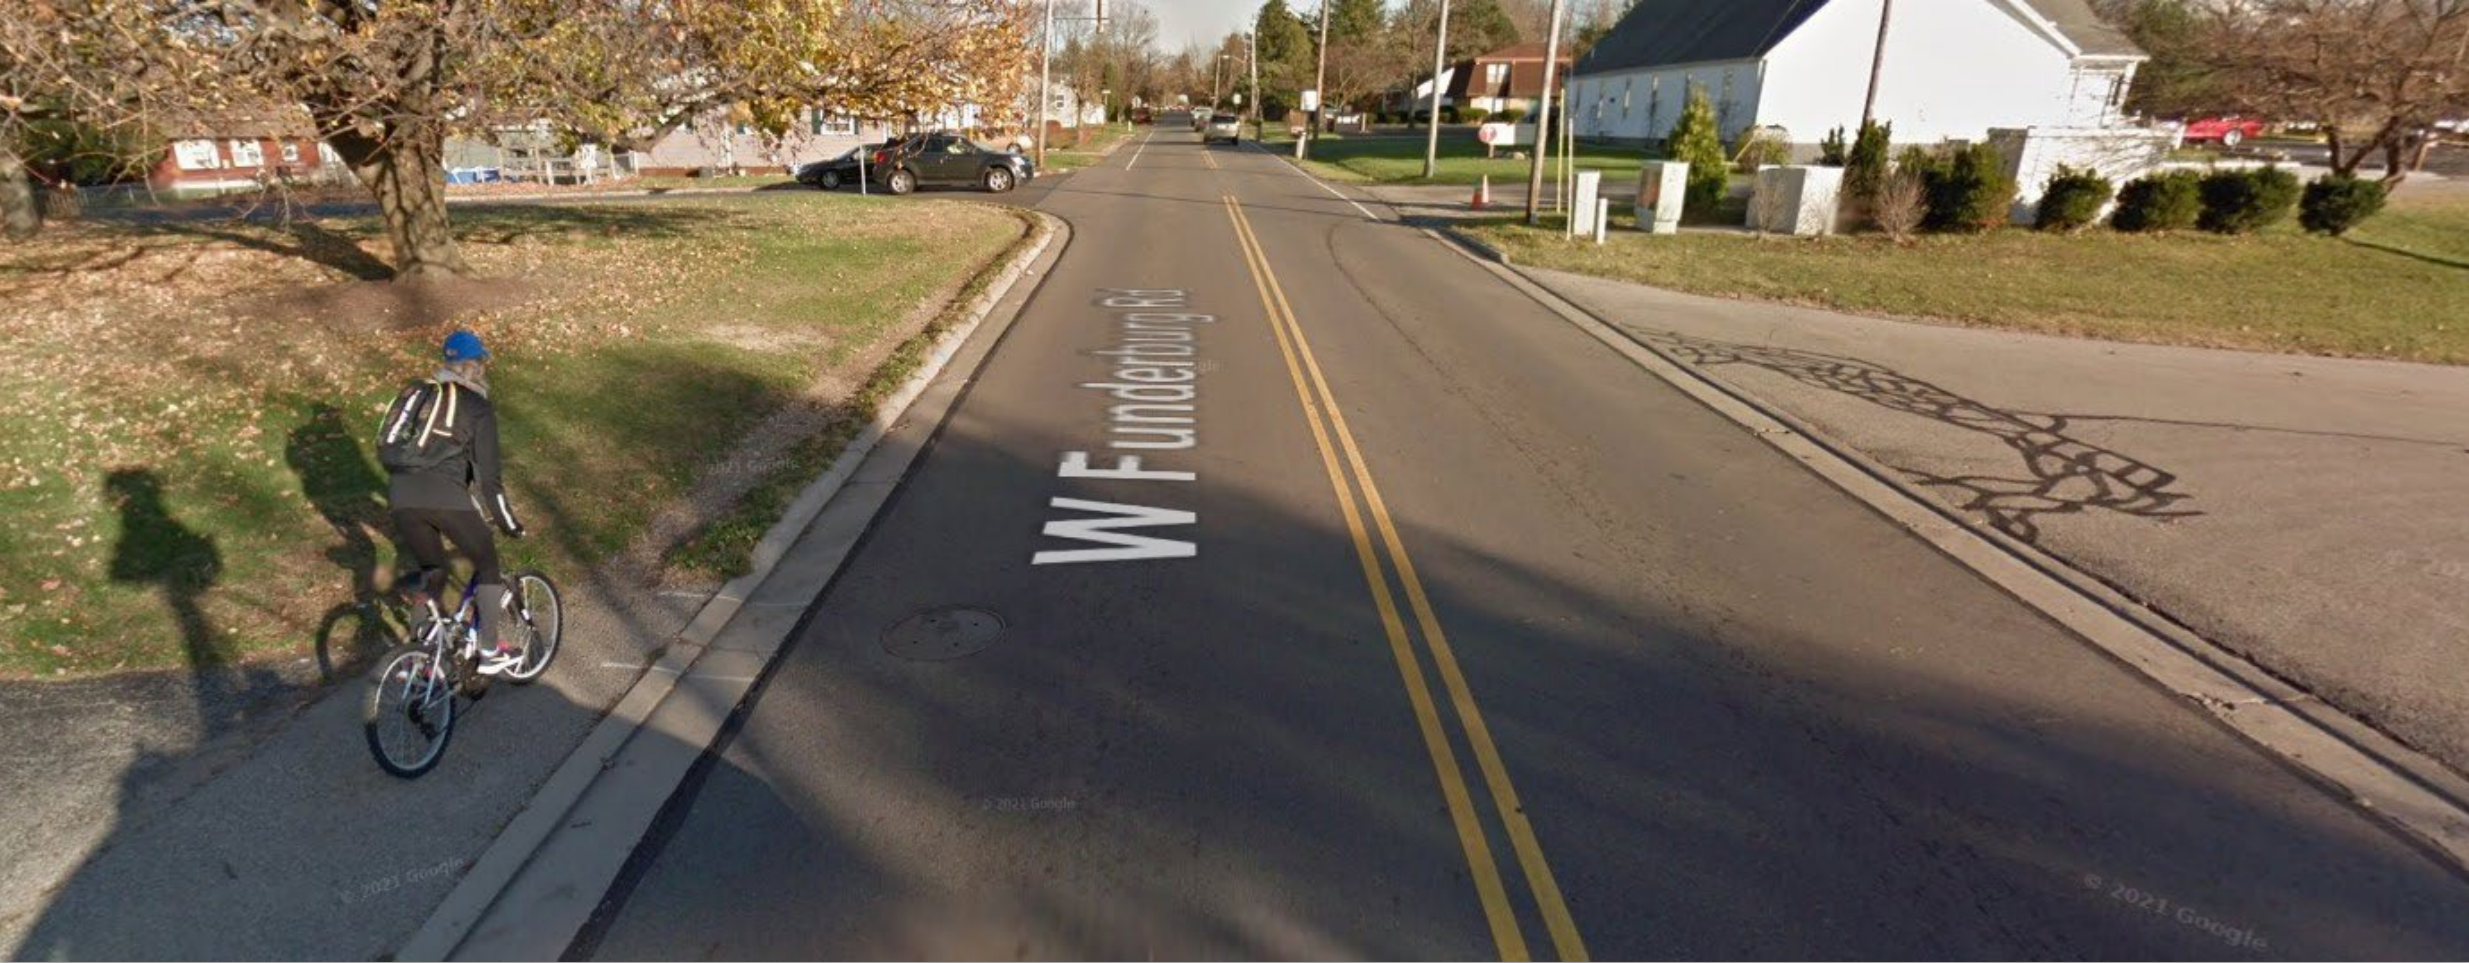
Photos: Funderburg Road (Google Streetview, 2022)

- **Sidewalk gaps**
- Some narrow sidewalks (older)
- Uncontrolled crossings may need updates
- Litter
- Lack of pedestrian scale lighting
